# Manhole Inspection Summary

Manhole # S23K\_\_062MH

**Location** Address: **1414 S Norris**

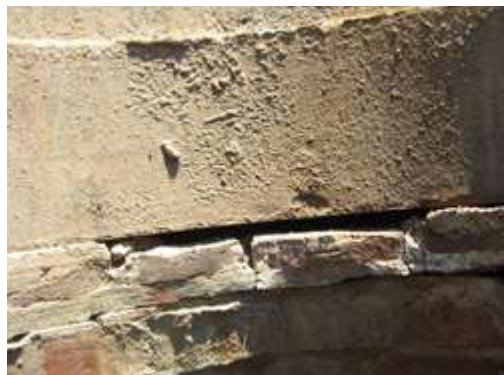
Defect 2

Condition: ☐ Sound ☐ Cracked ☒ **Leaks**

Condition: ☐ Sound ☐ Cracked ☐ Root Intrusion ☐ Loose Brick ☒ **Deteriorated**

Infiltration: ☐ None ☒ **Joint** ☐ Cracks ☒ **Mortar** ☐ Roots ☐ Wall

frame leaking, chimney deteriorated with sign of flow at joint & mortar

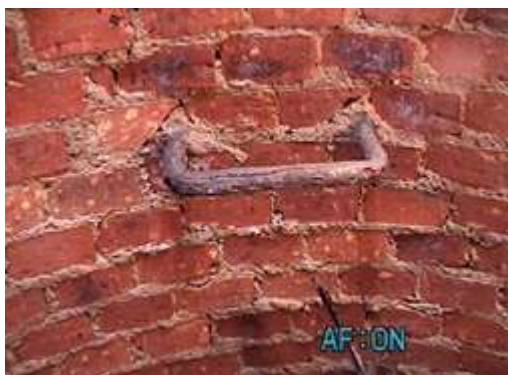
Defect 1

Count: **7** Missing: **0** ☒ **Corroded**

corroded rungs 3

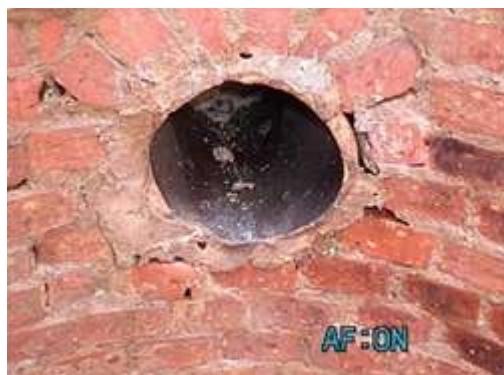
Defect 3

Condition: ☐ Sound ☐ Cracked ☐ Root Intrusion ☒ **Loose Brick** ☐ Deteriorated

missing mortar barrel bricks

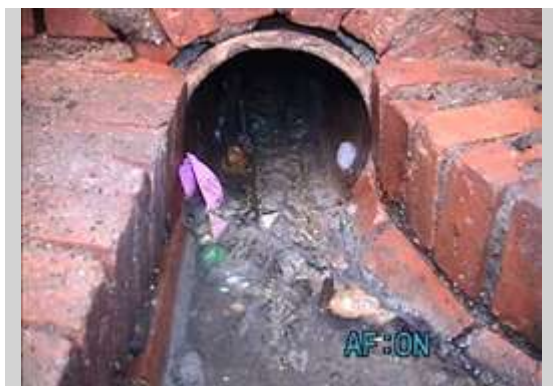
12 O'Clock Outflow

Deposits: ☐ None ☐ Mud ☐ Sludge ☒ Debris ☐ Grease

Silt Depth: **2** (in.) Deposits Extent: **Medium**

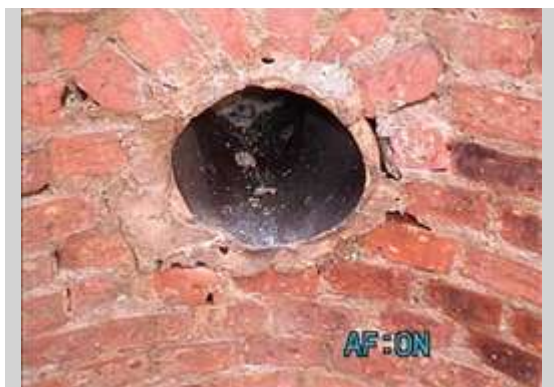
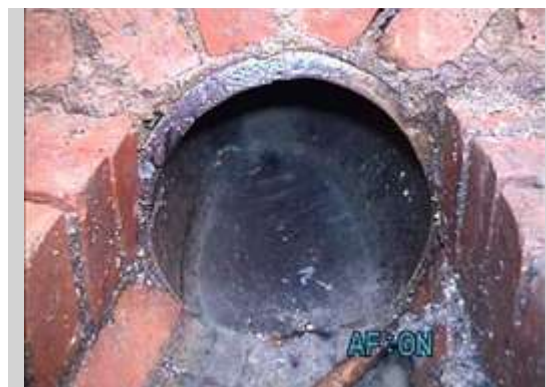
3 O'Clock Inflow

Pipe Height: **8.4** (in.) Rod and Bar (Angled)  
Pipe Material: **Clay** ☐ Pipe Lined  
Invert Depth: **6.99** (ft.) Flow Characteristics: **None**  
Deposits: ☐ None ☐ Mud ☒ **Sludge** ☐ Debris ☐ Grease  
Silt Depth: **1** (in.) Deposits Extent: **Medium**  
Infiltration: **None** Pipe Seal Cond: **Sound**

Drop: **Outside** Rod and Bar  
Angled: **Yes** Reading: **10.08** (ft.)  
Inv Depth: **11.08** (ft.)  
Drop Condition: **Open**

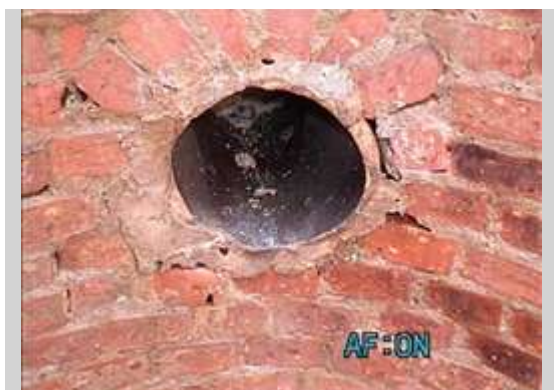
Defect 3

missing mortor barrel bricks
